FLIGHT MEASUREMENTS OF THE FLYING QUALITIES

OF AN F6F-3 AIRPLANE (BUAER NO. 04776)

II - LATERAL AND DIRECTIONAL STABILITY AND CONTROL

By Walter C. Williams and John P. Reeder

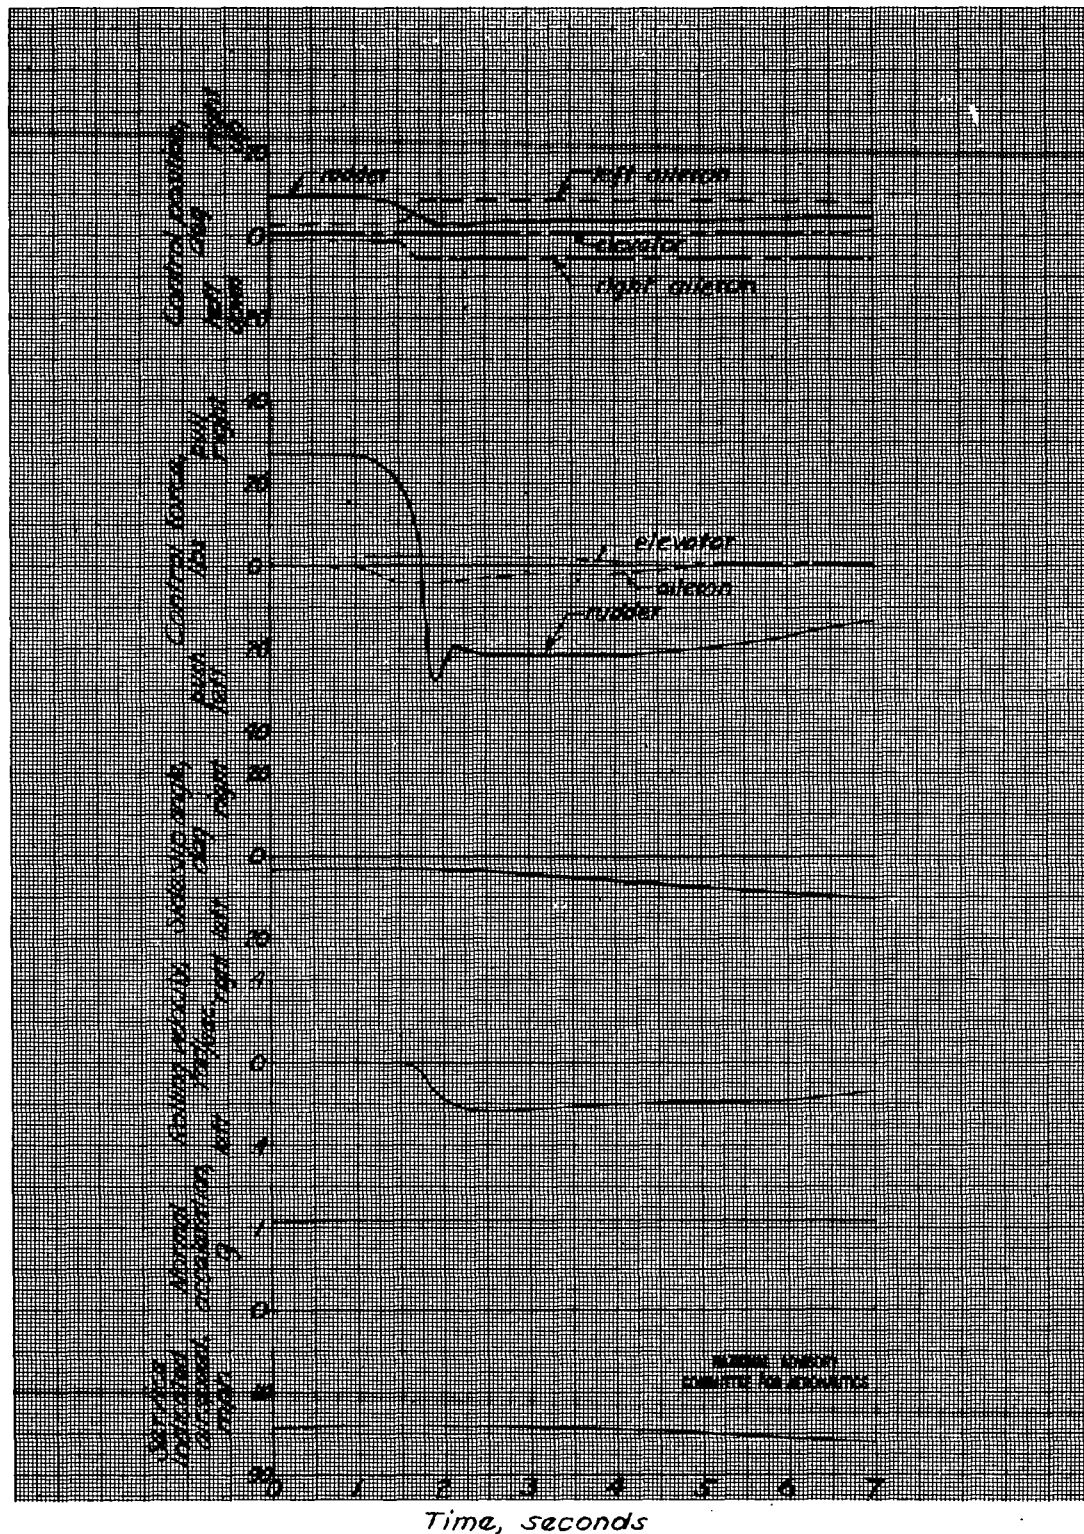
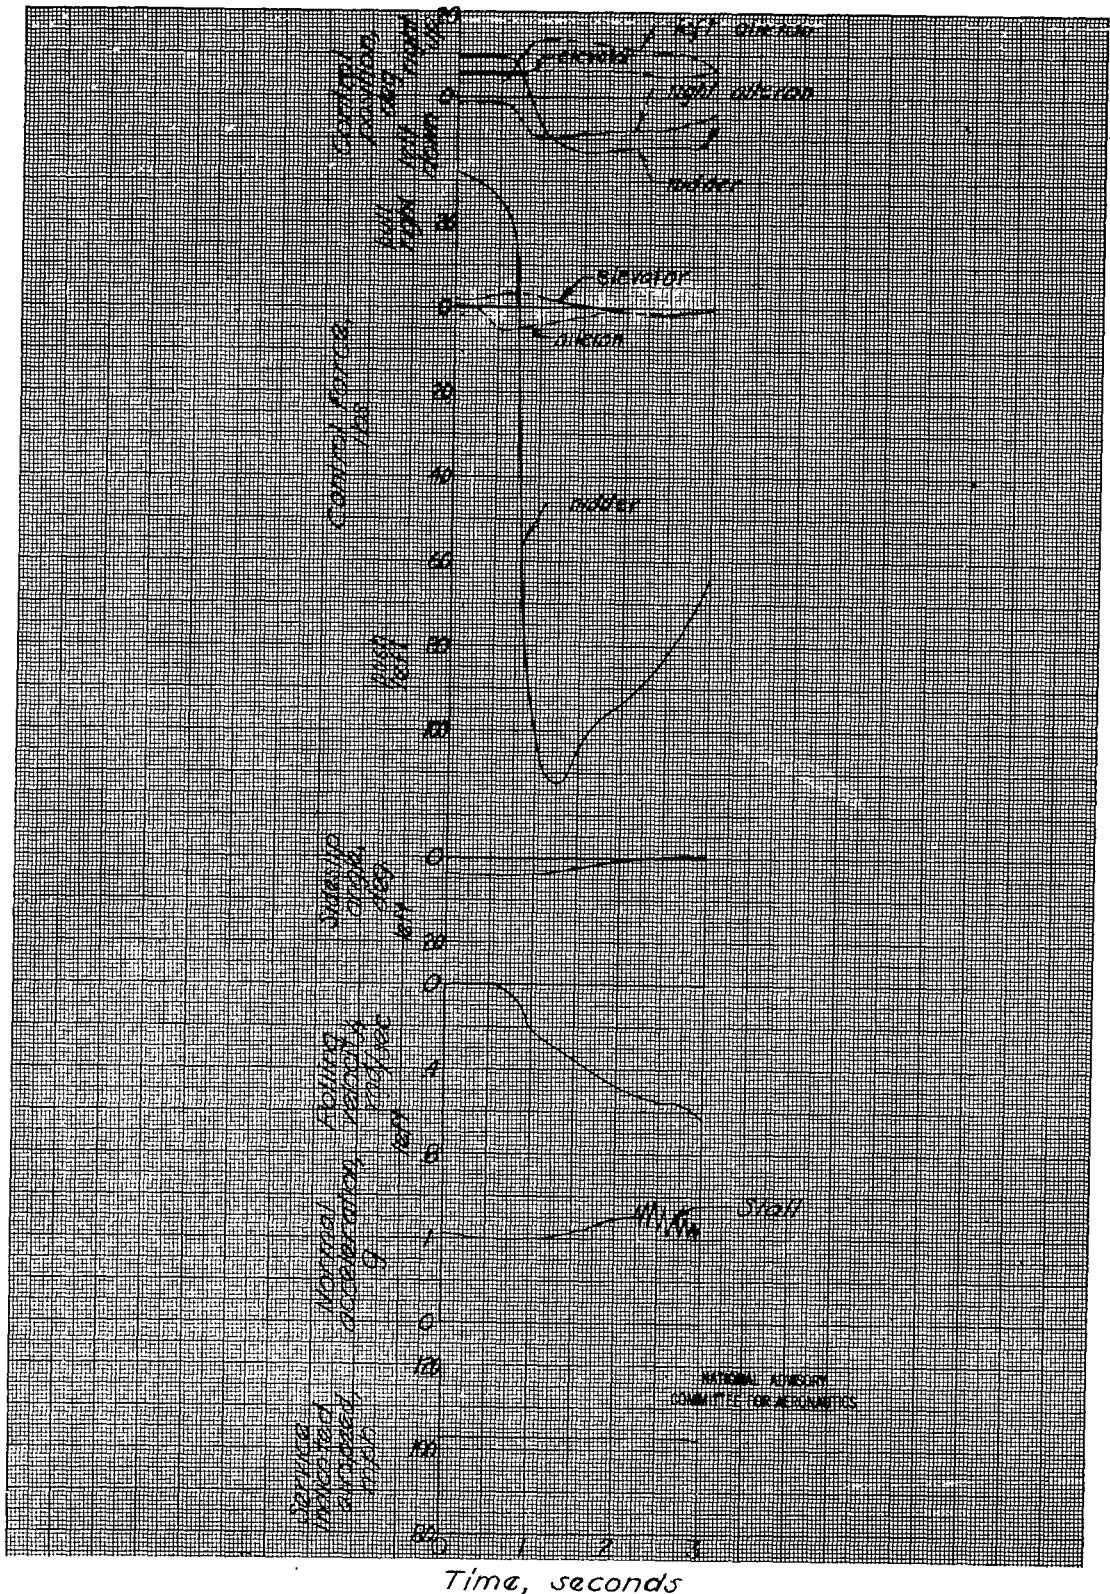
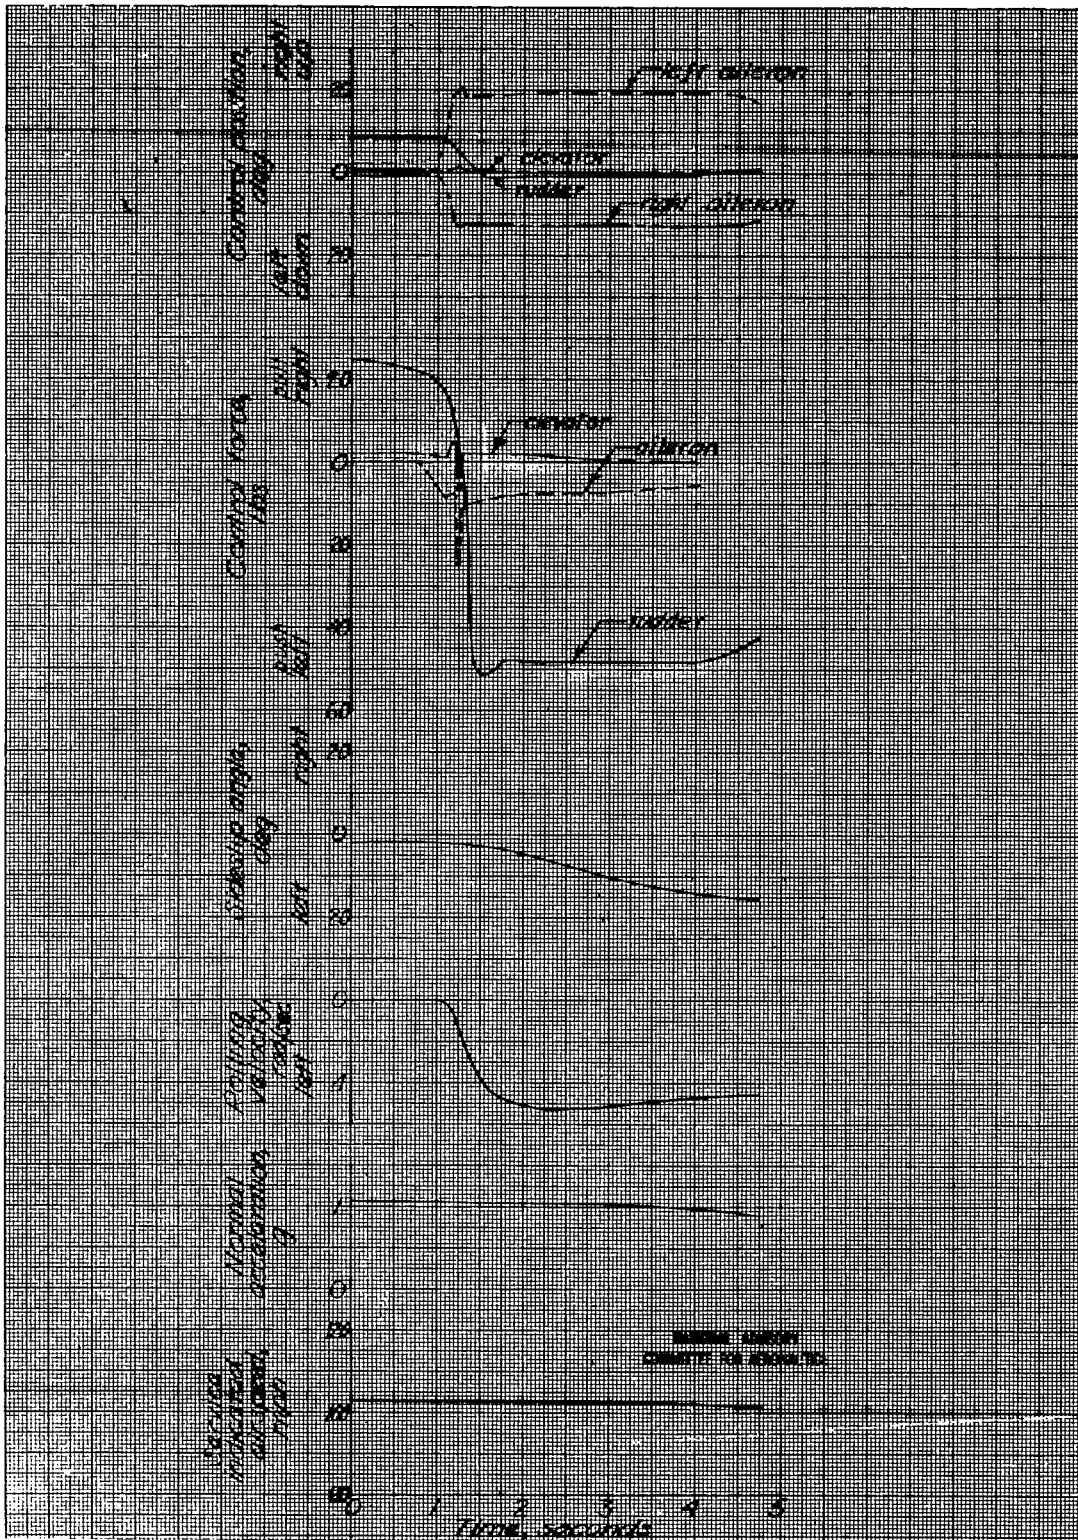
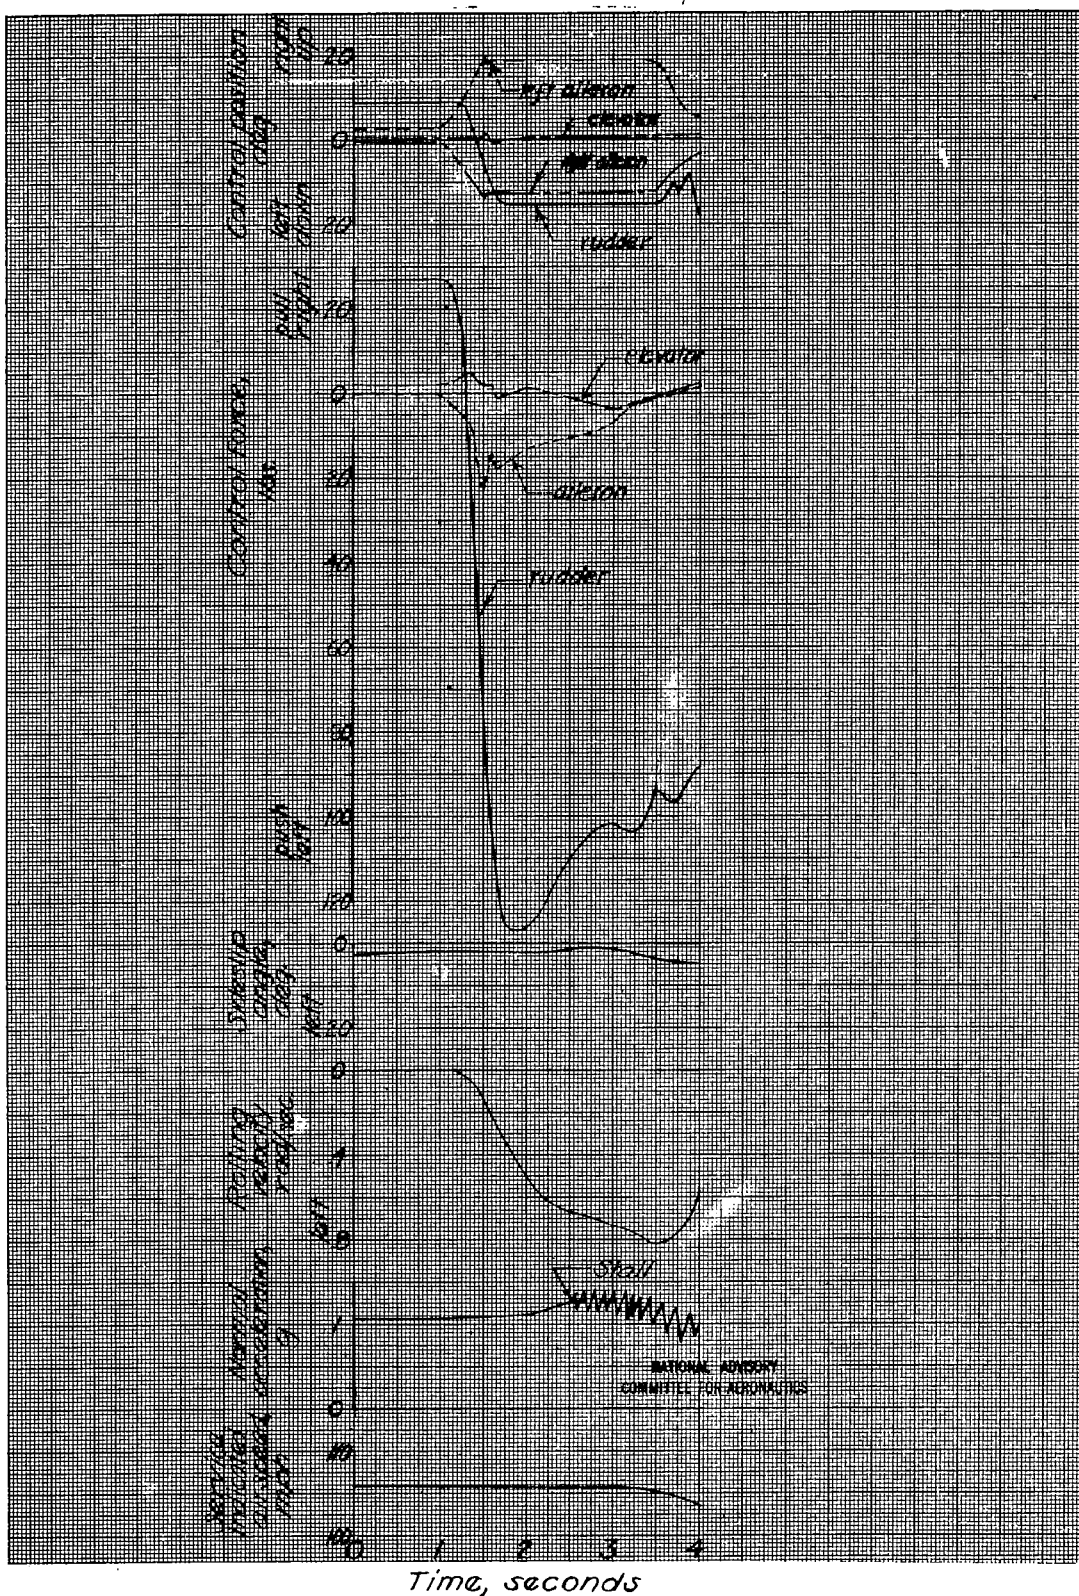
Figure 37.- Time history of rolling out of a right turn using partial aileron control and less rudder than necessary to overcome adverse aileron yaw. Clean condition, power for level flight, F6F-3 airplane.

Figure 38.- Time history of rolling out of a right turn using partial aileron control and more rudder than necessary to overcome adverse aileron yaw. Clean condition, power for level flight, F6F-3 airplane.

Figure 39. - Time history of rolling out of a right turn using full aileron deflection and less rudder than necessary to overcome adverse aileron yaw. Clean condition, power for level flight, F6F-3 airplane.

Figure 40.- Time history of rolling out of a right turn using full aileron and slightly more rudder deflection than necessary to overcome adverse aileron yaw. Clean condition, power for level flight, F-3 airplane.

1. The power of the rudder in overcoming adverse aileron yaw was determined in rolls out of turns. Rolls were made where the pilot used less rudder deflection than he thought necessary to overcome adverse yaw and where the pilot used more rudder than he thought necessary to overcome adverse yaw. These maneuvers were made in the clean condition with power for level flight. Typical maneuvers of this type are shown in figures 37 to 40. It can be seen from inspection of these figures that 15° of rudder deflection is sufficient to maintain zero sideslip while using full aileron deflection at approximately 105 miles per hour. The change in rudder force is considerable (154 pounds) but is within the specified limit of 180 pounds (references 2 and 3).

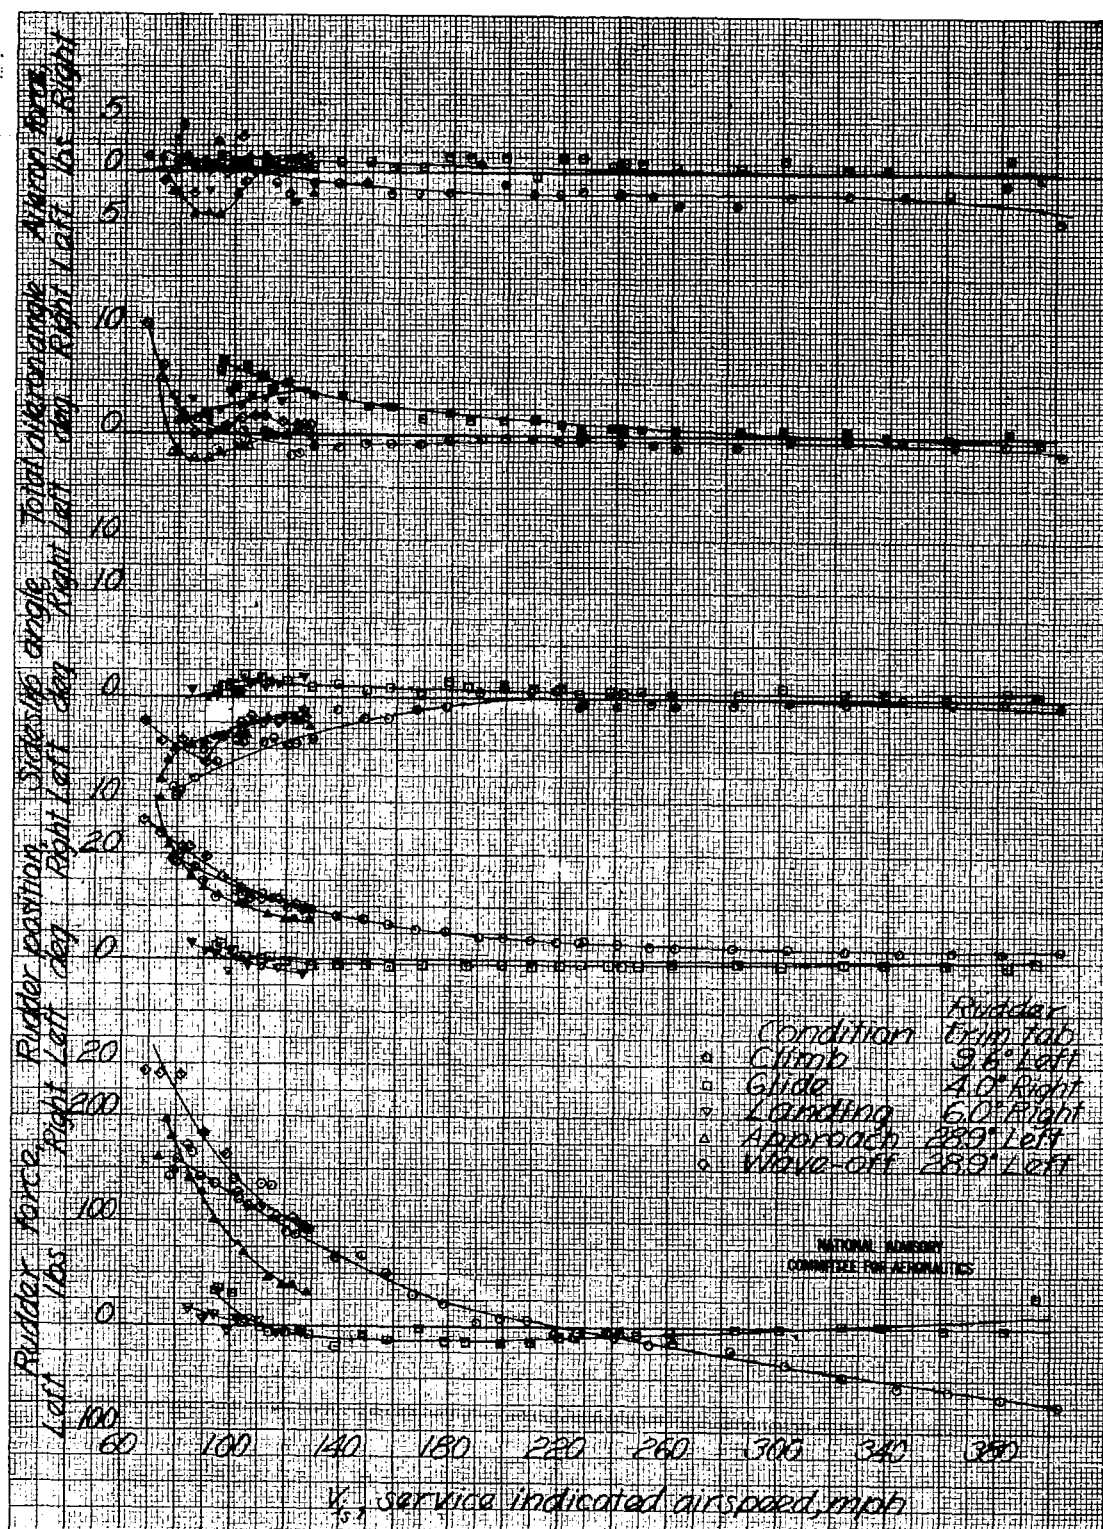
Figure 41. - Directional and lateral trim characteristics, F6F-3 airplane.

4. The directional trim characteristics were determined by measuring the rudder forces and angles required to trim at various speeds. These data are presented in figure 41 as the variation of rudder force and angle with indicated airspeed for various flight conditions. Figure 41 also shows the variation of aileron angle and force, and sideslip angle with indicated airspeed. There is no requirement specified for the change in rudder trim force with speed, but the pilots felt that in the case of the F6F-3 these changes in force were excessive. The pilots also reported a rudder shake which was present throughout the speed range in all flight conditions, which may be caused by a turbulent flow behind the elevator cutout.

The power of the rudder trim tabs was measured in a manner similar to that used to determine the power of the elevator tabs. Measurements were made in the gliding and climbing condition. Figure 41 shows the variation of rudder pedal force with speed for two trim-tab settings in the gliding and climbing condition. The data were used to determine the change in rudder pedal force per degree trim-tab deflection. This factor is plotted as a function of indicated airspeed in figure 42.

No quantitative measurements were made of the power of the aileron trim tab. The aileron trim forces were small as shown by figure 41. The aileron trim tab was reported by the pilot to be adequate for trimming the airplane within the conditions and speed range tested.

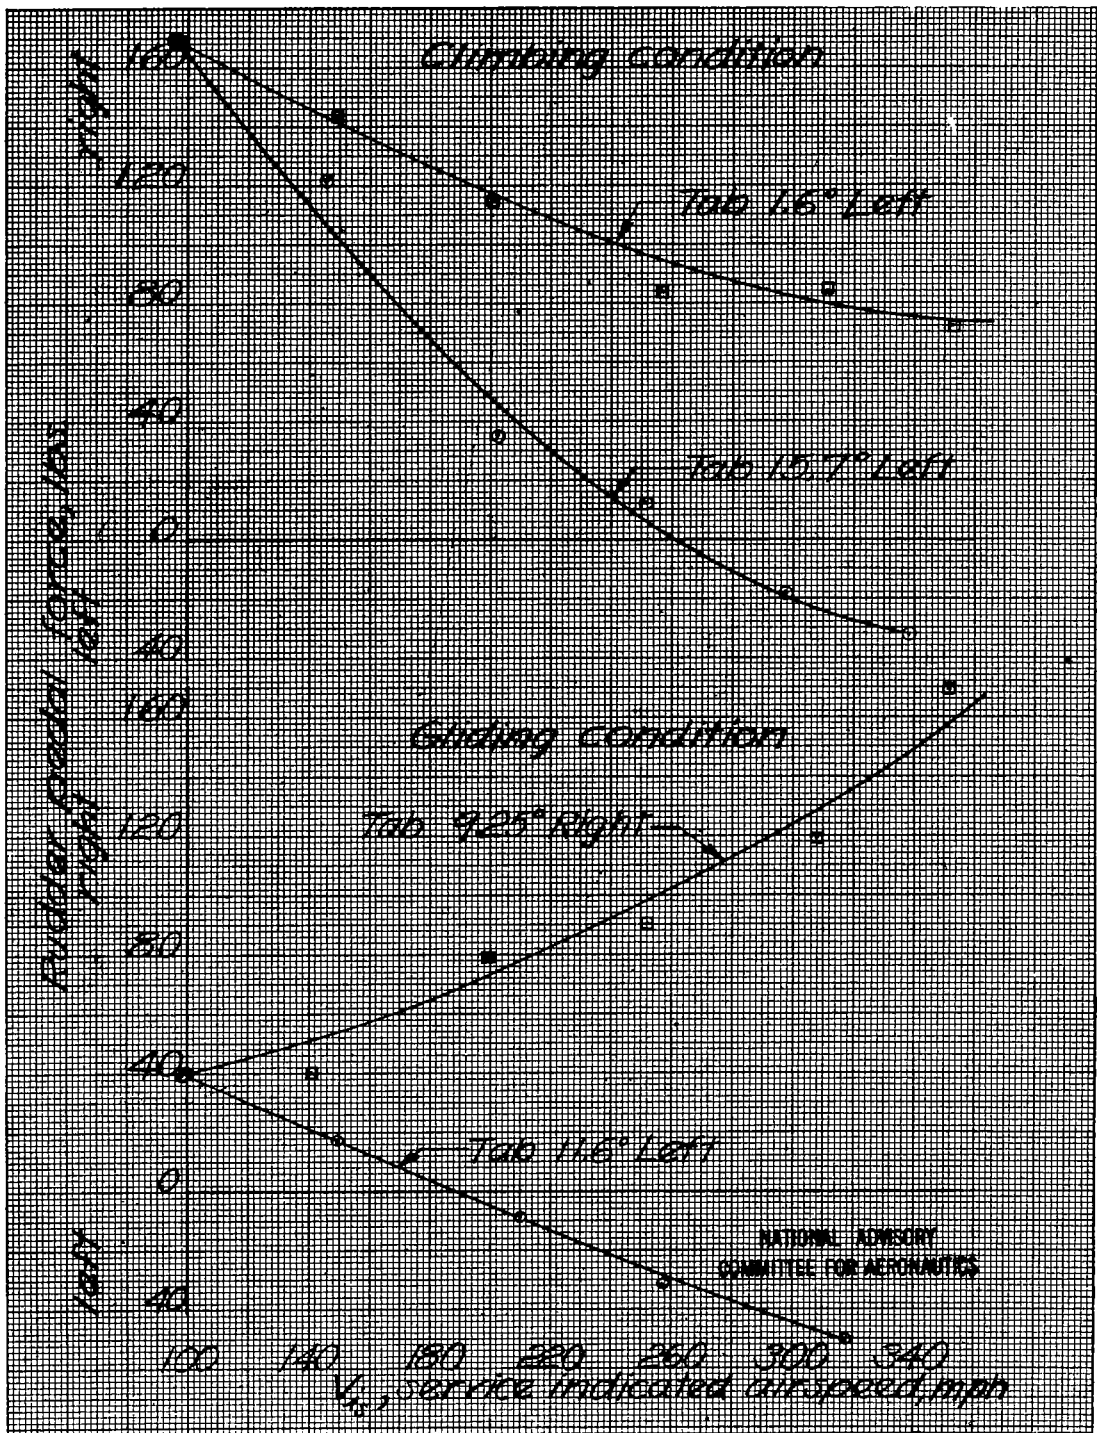
Figure 42. - Variation of rudder pedal force with indicated airspeed for two trim tab settings, gliding and climbing condition, F6F-3 airplane.

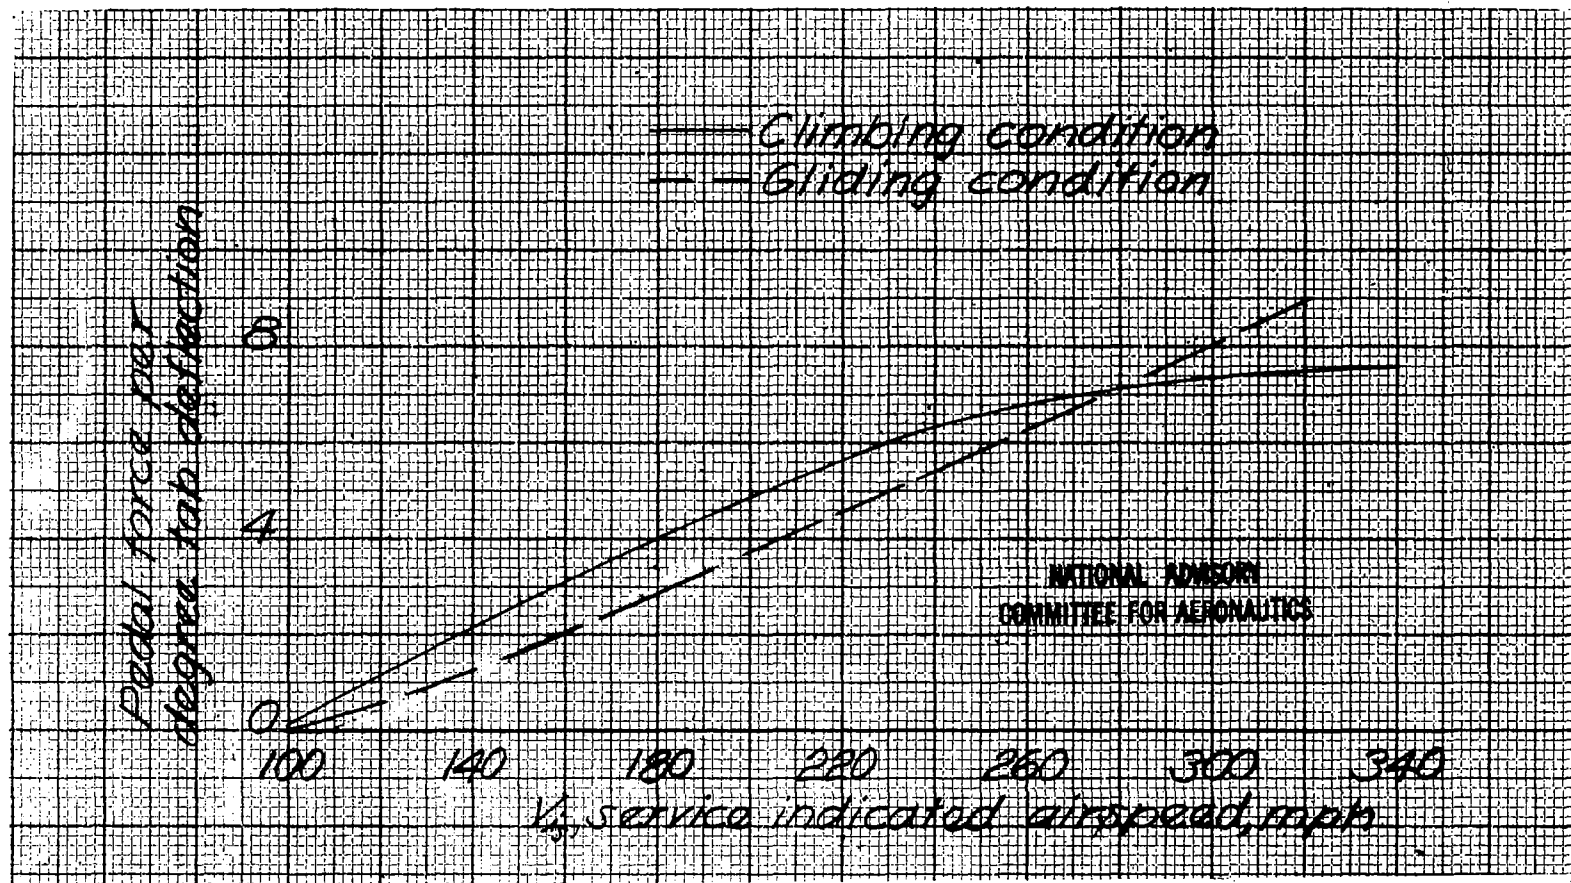
Figure 43. - Variation of rudder pedal force per degree trim tab deflection with indicated airspeed, gliding and climbing condition, F6F-3 airplane.

From the data shown on figures 41 and 43, the following may be concluded regarding the power of the rudder trim tab of the F6F-3 airplane:

1. The rudder pedal force could not be trimmed to zero below approximately 155 miles per hour in the climbing condition.

2. The rudder trim tab was adequate in the gliding condition from approximately 100 miles per hour to the highest speeds tested.

3. The rudder pedal force could not be trimmed to zero with full deflection of the trim tab in either the approach or wave-off condition in the speed range tested.

4. The trim tab was sufficiently powerful in the landing condition to trim the rudder pedal forces to zero at 100 miles per hour with approximately half tab deflection.

5. In the gliding and climbing condition, deflection of the rudder tab caused no change in pedal force below 100 miles per hour.

6. At 280 miles per hour, 1° deflection of the trim tab caused a change in rudder hinge-moment coefficient of 0.0019.
